**Flood Control Project Maintenance
Levee Inspections**

Maintenance Issue Types Only, Levee Inspection Report By Mile - Spring 2017

Reclamation District No. 2104 Peters Pocket Tract

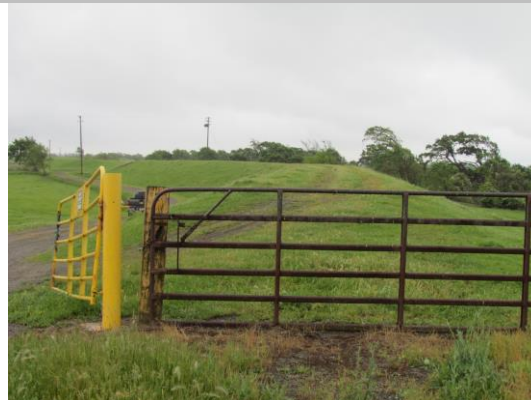
Photo 1 of 1 : SP_2017_RD2104_249_11_20170523_00042.jpg

| V1 : Control annual grass and weeds on the levee slopes and easements. | | | | | |

RD 2104 Looking downstream from 0.00 -0.88.

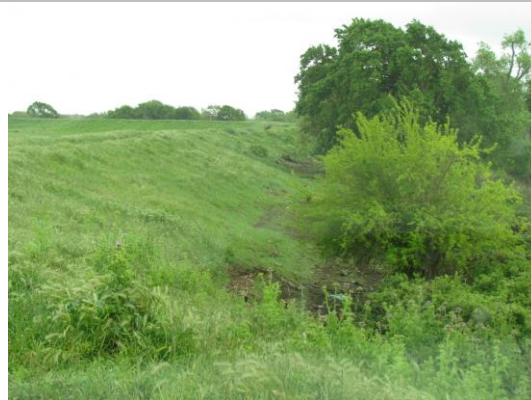
Photo 1 of 1 : SP_2017_RD2104_249_17_20170518_00039.jpg

RD 2104 Waterside levee slope levee mile 0.01-1.43.

| Control annual grasses and weeds on the waterside slope. | | | | | |

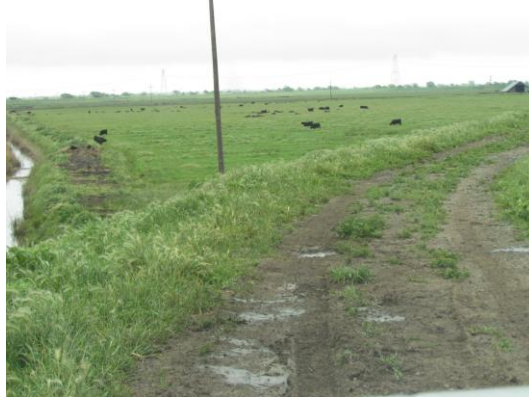
Photo 1 of 1 : SP_2017_RD2104_249_26_20170523_00043.jpg

| No maintenance has been done to the levee section from levee mile 0.88-5.72. | | | | | |

RD 2104 Looking downstream from levee mile 0.88- 5.72.

| V1 : Control annual grass and weeds on the levee slopes and easements. | | | | | |

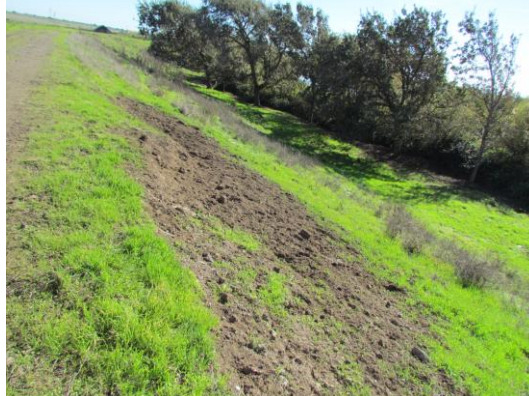
Photo 1 of 1 : SP_2017_RD2104_249_22_20170404_00002.jpg

RD 2104 Levee mile 1.20 waterside slope.

| Make the repairs to the erosion site listed on the waterside slope. | | | | | |

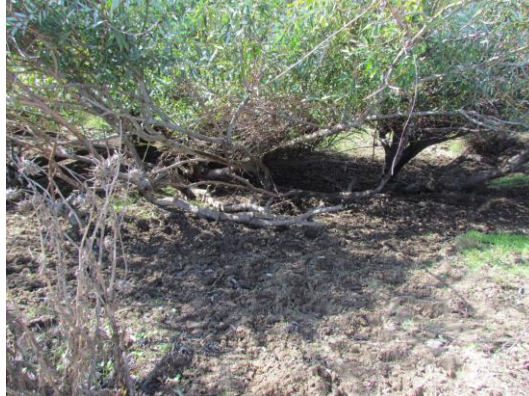
Photo 1 of 1 : SP_2017_RD2104_249_23_20170404_00003.jpg

RD 2104 Levee mile 1.27 wateside.

| Repair the slope damaged by cows and trim up the tree limbs partially blocking the erosion site. | | | | | |

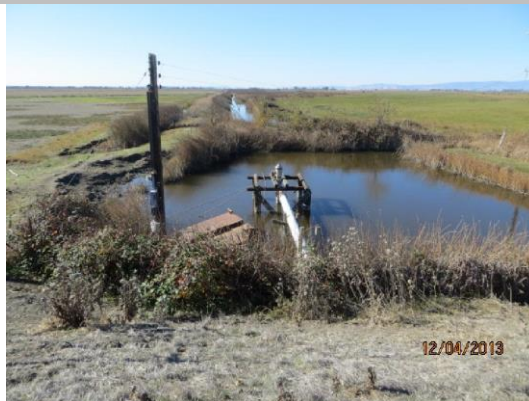
Photo 1 of 3 : UCIP_SP_2017_51640_45056.jpg

FS_ID:51640
DS_ID:24706
EP_NO: 10183
Repair Type: Urgent
Crossing Status: Found
UCIP Comments: 12/06/2016 Pipe has been replaced with PVC pipe. The crossing is non-functional due to pipe not attached to new pump. Need to contact owner. Owner will need to coordinate with CVFPB regarding the modifications made to this crossing (modifications include pipe replacement, material used for pipe replacement, and debris left from construction on levees). (O. Magana - DWR UCIP)12/04/2013
Pipe rusted through on WS berm. Siphon breaker in CMP riser blocked by riser misalignment. (W. Wylie - DWR UCIP)
FIELD_STRUCT_DESC: *REMOVED* 12-inch steel drainpipe through the levee, 4 feet below the crown. Pump on pile structure in drainage ditch is located on the landside (LS). One corrugated metal cutoff wall and a siphon breaker in a 24-inch corrugated metal pipe (CMP) riser located on the waterside (WS) shoulder. Flap gate is located on the WS end. (12-inch pipe removed in 2016 no permit found authorizing work; 12-inch pipe authorized under Automatic Board Order (ABO) issued as Permit No. 10183, 1974 - Miller) [Additional Reference(s): DWR Levee Log, 2006. USACE Sacramento O&M Manual Unit 108, April 1964, As-built drawing no. 50-04-3379 (HLM 4.32)].

Pump on pier off LS toe at ponding area. power pole and meter on LS toe.

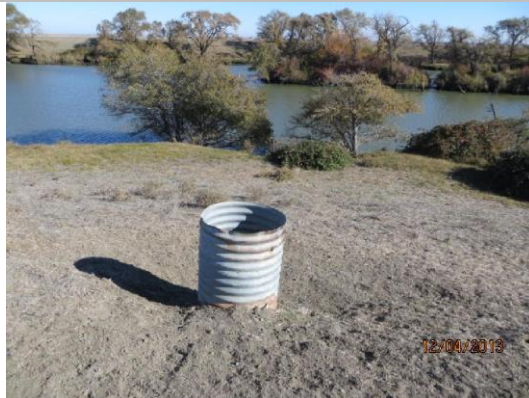
Photo 2 of 3 : UCIP_SP_2017_51640_45055.jpg

Siphon breaker in CMP riser on WS slope.

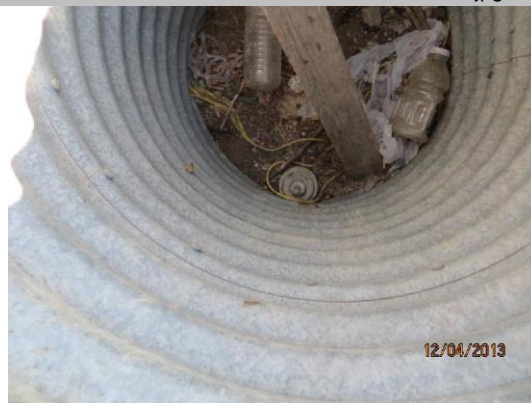
Photo 3 of 3 : UCIP_SP_2017_51640_45054.jpg

FS_ID:51640
DS_ID:24706
EP_NO: 10183
Repair Type: Urgent
Crossing Status: Found
UCIP Comments: 12/06/2016 Pipe has been replaced with PVC pipe. The crossing is non-functional due to pipe not attached to new pump. Need to contact owner. Owner will need to coordinate with CVFPB regarding the modifications made to this crossing (modifications include pipe replacement, material used for pipe replacement, and debris left from construction on levees). (O. Magana - DWR UCIP)12/04/2013
Pipe rusted through on WS berm. Siphon breaker in CMP riser blocked by riser misalignment. (W. Wylie - DWR UCIP)
FIELD_STRUCT_DESC: *REMOVED* 12-inch steel drainpipe through the levee, 4 feet below the crown. Pump on pile structure in drainage ditch is located on the landside (LS). One corrugated metal cutoff wall and a siphon breaker in a 24-inch corrugated metal pipe (CMP) riser located on the waterside (WS) shoulder. Flap gate is located on the WS end. (12-inch pipe removed in 2016 no permit found authorizing work; 12-inch pipe authorized under Automatic Board Order (ABO) issued as Permit No. 10183, 1974 - Miller) [Additional Reference(s): DWR Levee Log, 2006. USACE Sacramento O&M Manual Unit 108, April 1964, As-built drawing no. 50-04-3379 (HLM 4.32)].

Siphon breaker in CMP riser blocked by the risers misalignment.

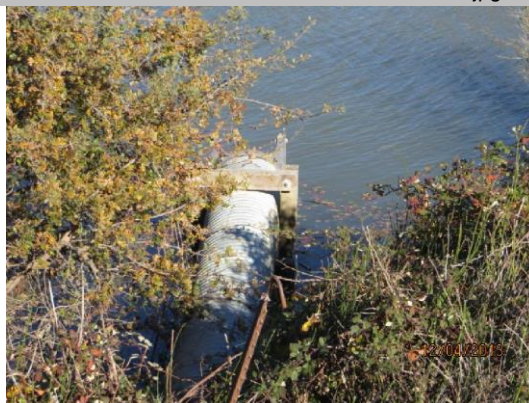
Photo 1 of 3 : UCIP_SP_2017_51459_45062.jpg

FS_ID:51459
DS_ID:24705
EP_NO: 10182
Repair Type: Non-Urgent
Crossing Status: Found
UCIP Comments: 12/06/2016 Crossing has been downgraded from "Urgent" to "Non-Urgent" no signs of leaks observed along pipe alignment (limited inspection on WS toe). According to LMA representative, this crossing was replaced 6 years ago (2010) at WS concrete apron. Recommend conducting internal inspection of pipe through the levee and LS to determine pipe integrity. (O. Magana - DWR UCIP) 12/04/2013 Vegetation and soil buildup throughout pipe preventing flapgate from closing. Remove vegetation to allow gate to close properly. (W. Wylie - DWR UCIP)
FIELD_STRUCT_DESC: 24-inch corrugated metal drainage pipe through the levee, 15 feet below the crown. 36-inch concrete standpipe located on the landside (LS) toe. Flapgate located on the waterside (WS) toe. Two corrugated metal (CM) cut of walls installed. (24-inch pipe authorized [HLM 4.65] under Automatic Board Order (ABO) issued as Permit No. 10182, 1974 - Machado) [Additional Reference(s): DWR Levee Log, 2006. USACE Sacramento O&M Manual Unit 108, April 1964, Asbuilt Dwg. 50-04-3379 (HLM 4.65)].

CMP pipe and flapgate off WS toe.

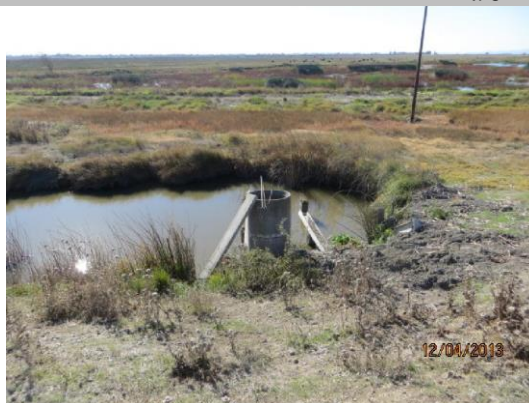
Photo 2 of 3 : UCIP_SP_2017_51459_45061.jpg

36-inch concrete riser on LS toe at channel.

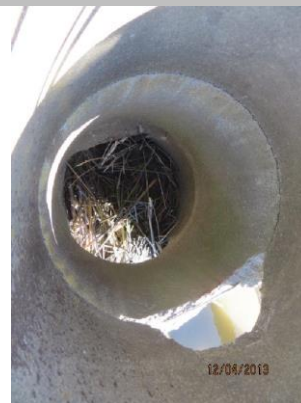
Photo 3 of 3 : UCIP_SP_2017_51459_45060.jpg

36-inch concrete riser with vegetation buildup inside.

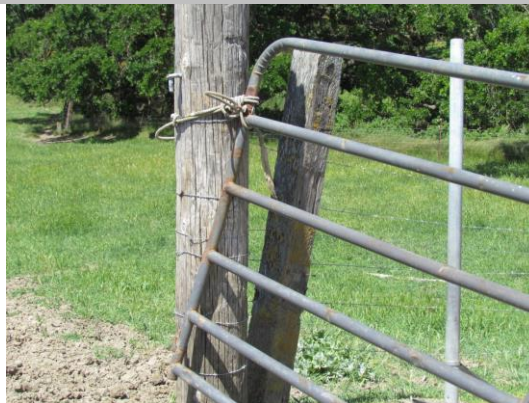
Photo 1 of 1 : SP_2017_RD2104_249_73_20170404_00005.jpg

Repair this gate at levee mile 5.72.

| Repair damaged gate. | | | | | |
